REPORT NO: 284-4994-1
CLIENT NO: L19154
DATE: April 7, 1999

DESCRIPTION: **Drop Tests on Hi-Rise Safety Line Strap Anchor Assemblies**
PROJECT: Ledcor
CLIENT: **Safe-T-Strap**
20 Bermondsey Road, Toronto, Ontario M4B 1Z5
ATTENTION: Mr. Richard Vallance

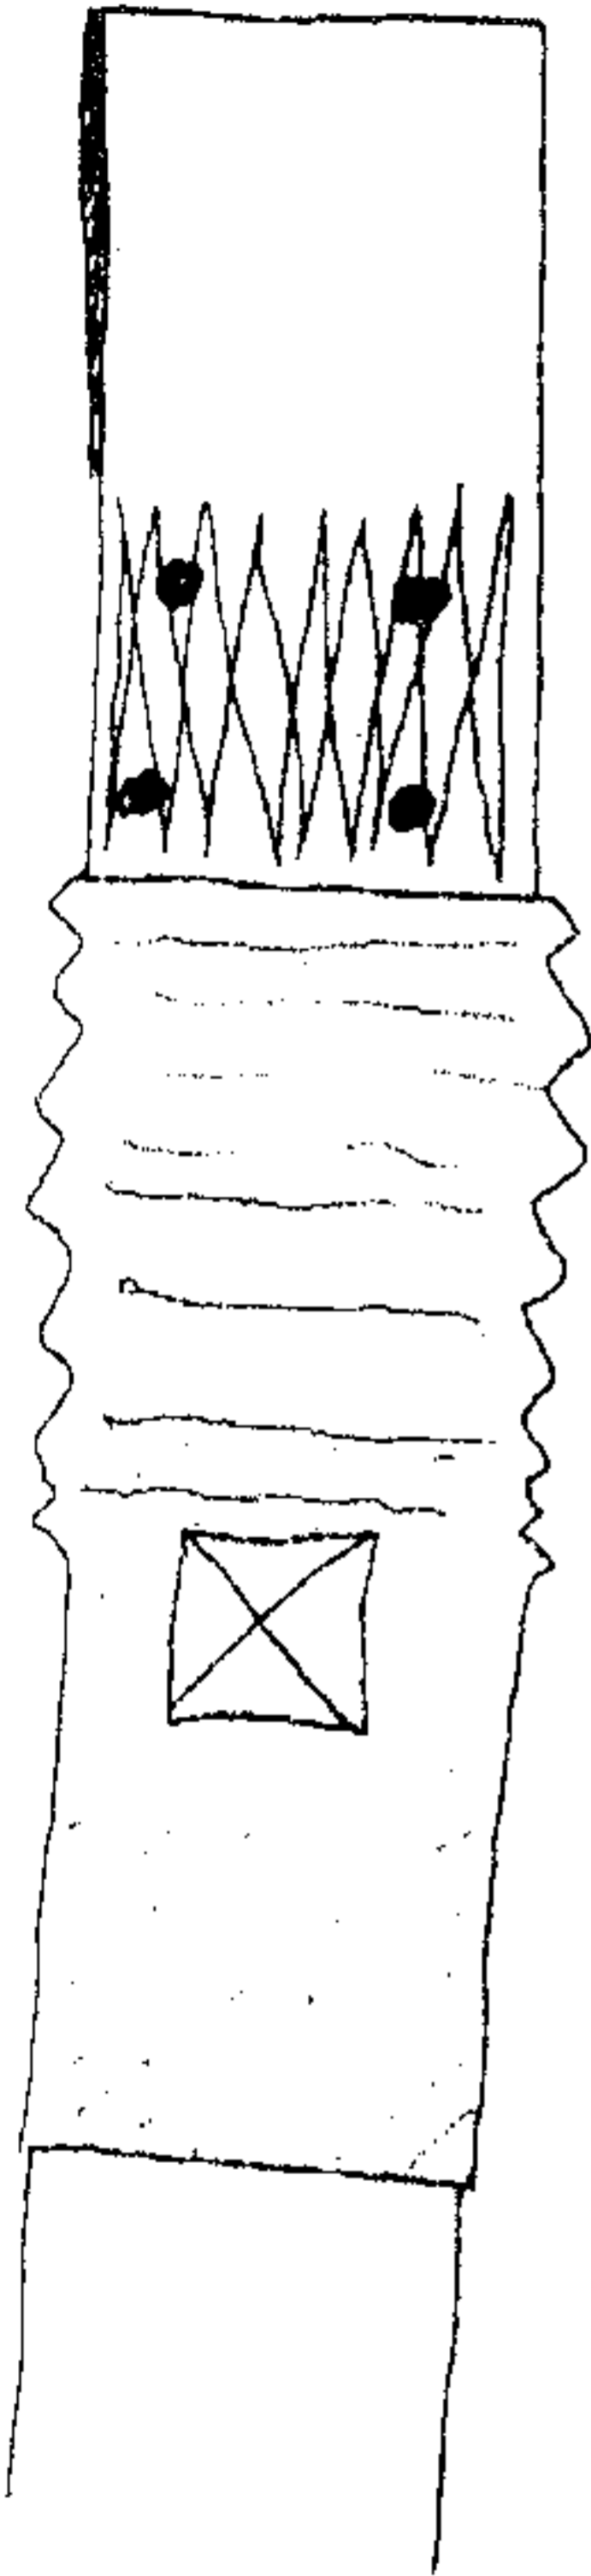
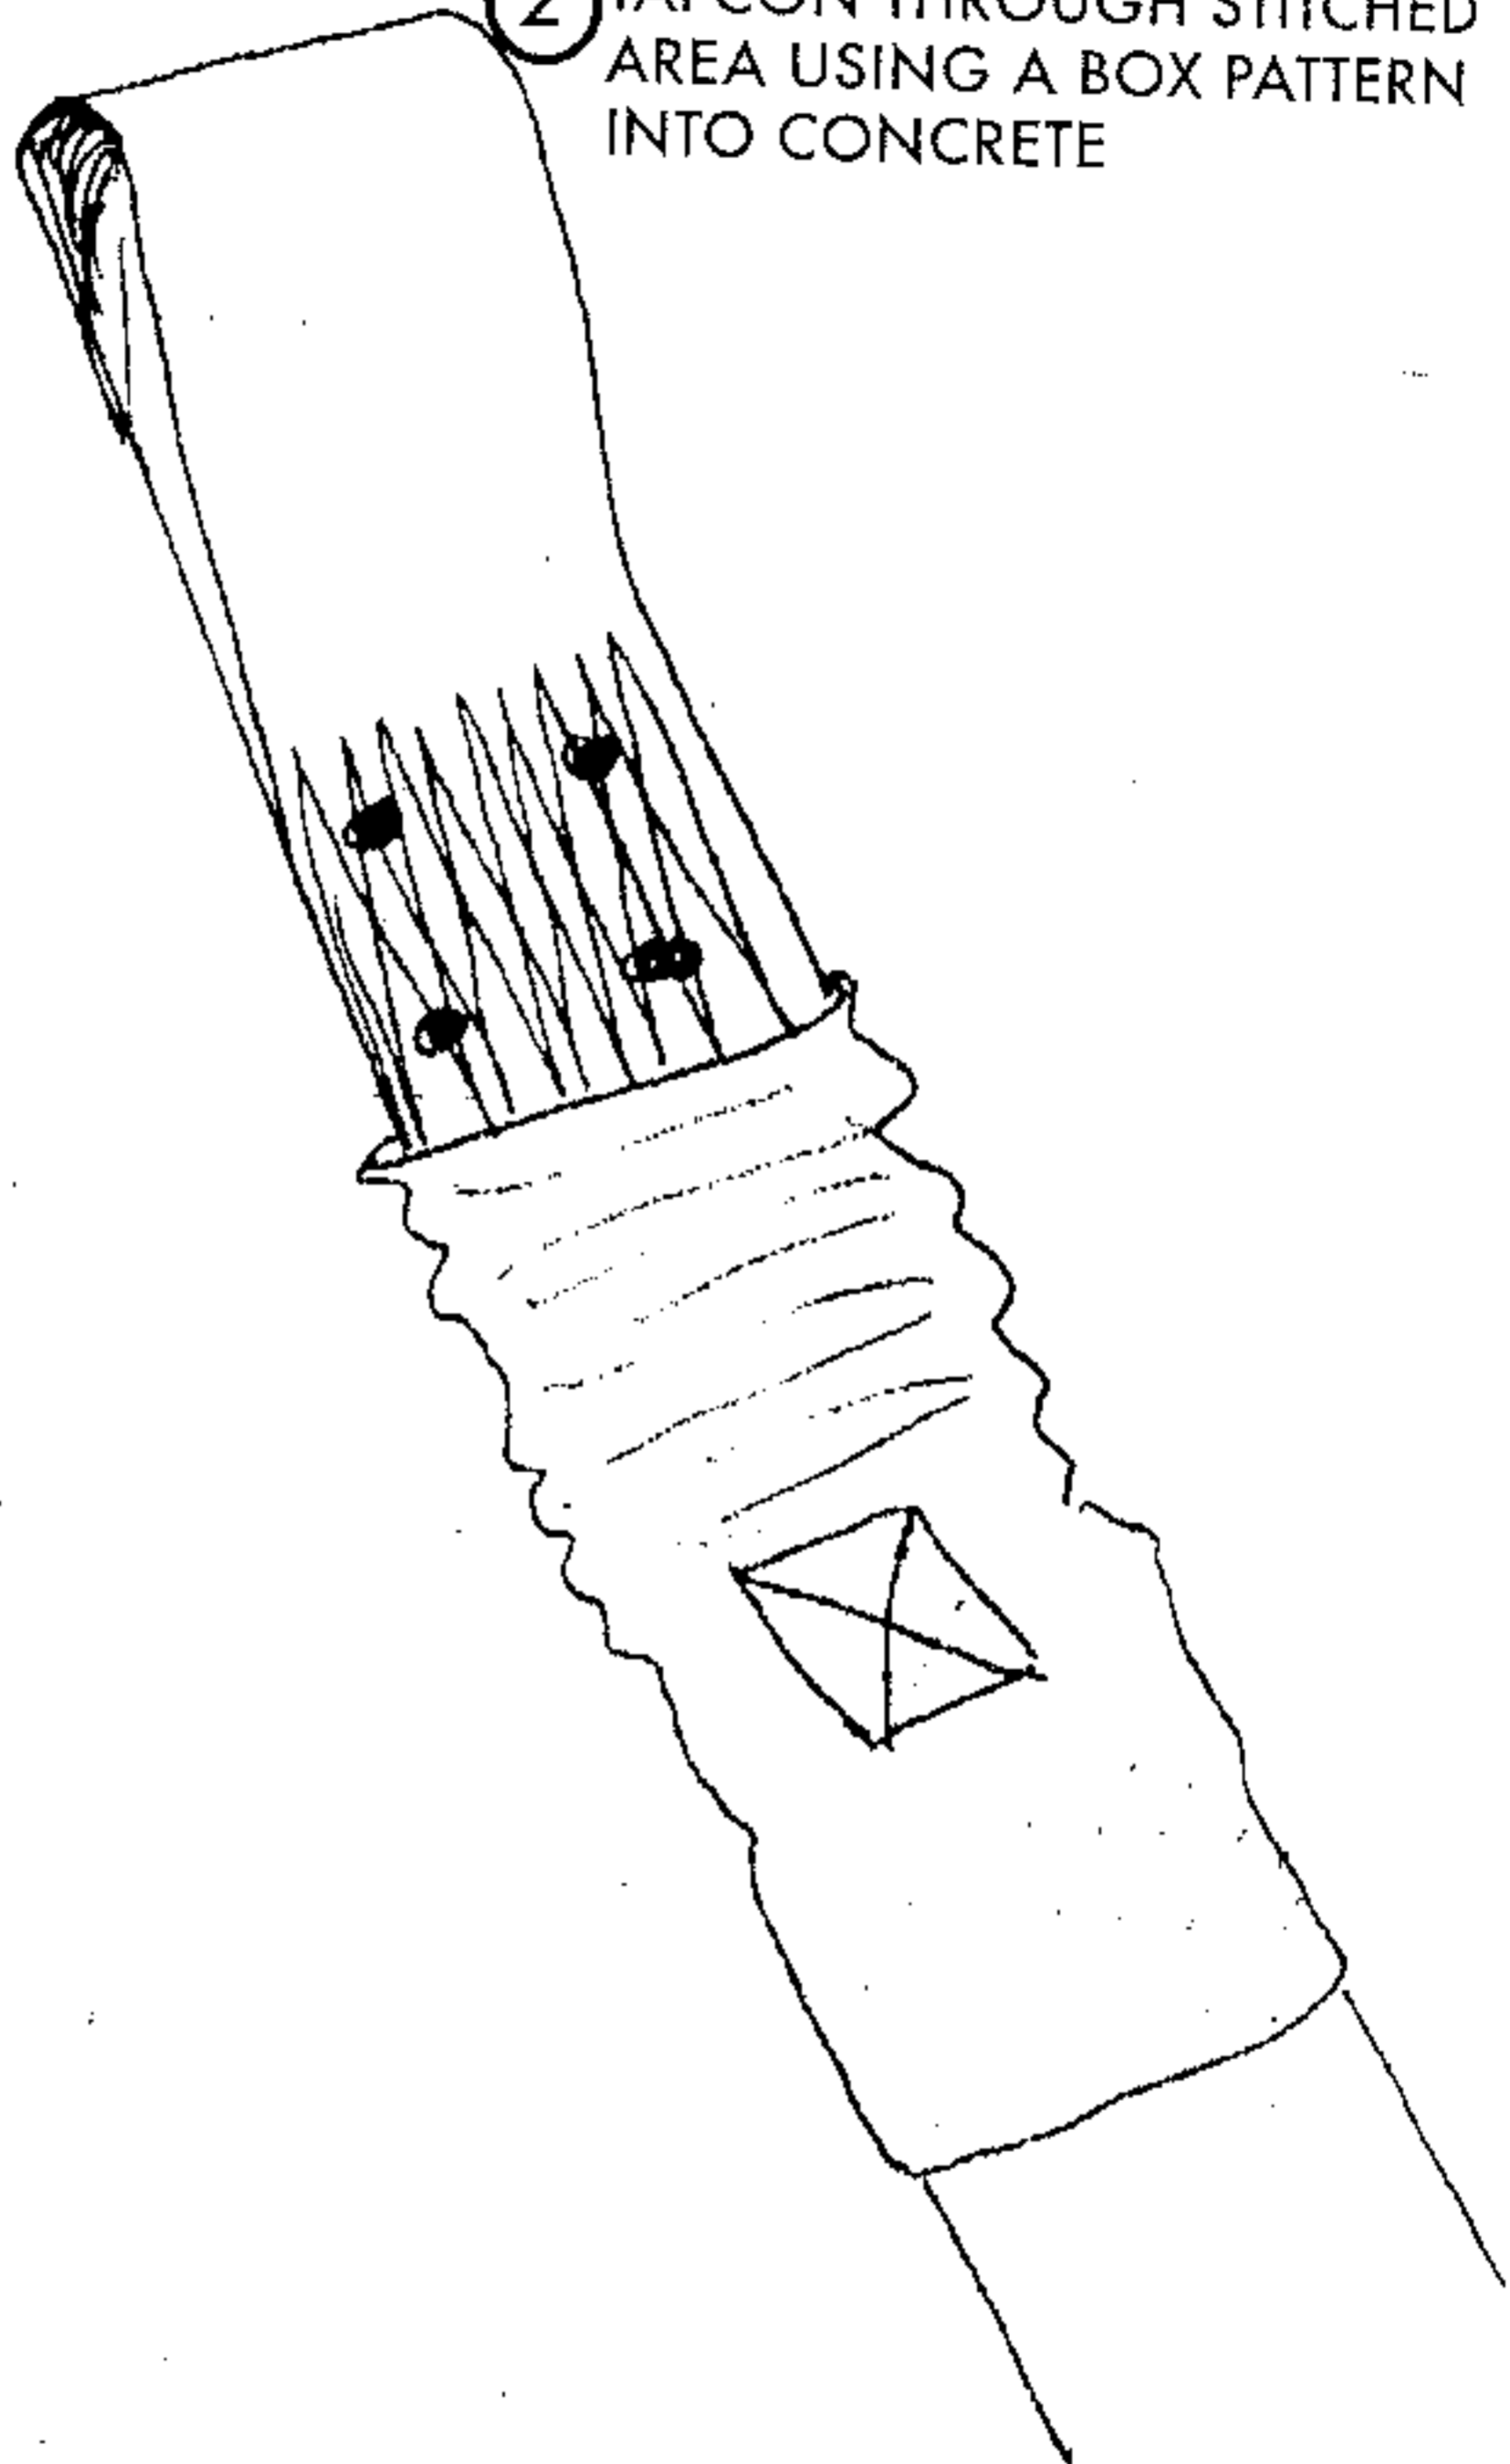
① PULL BACK GREEN SLEEVE

② TAPCON THROUGH STITCHED AREA USING A BOX PATTERN INTO CONCRETE

Each safety line strap assembly measured 42" long overall and consisted of a length of 2" nominal wide dyed yellow nylon 8000 lb. capacity webbing with a 3/8" thick, 2-3/4" x 3" overall steel 'D'-ring at one end held by a stitched loop formed by the webbing. This loop was overlapped once, the overlap measuring 4-1/4" long and was stitched by a "double zigzag (2WW)" stitch pattern measuring 2-1/4" x 1-1/2" overall. The other end of the strap was overlapped twice, the overlapped portion measuring 5-1/4" long overall. These three layers of strap were sewn together using the "double zigzag (2WW)" stitch pattern measuring 2-1/4" x 1-1/2" overall.
